The City of Columbia Wastewater Consent Decree specifies that several Supplemental Environmental Projects (SEP) must be completed. The following is the Consent Decree language related to Phase I of the Gills Creek SEP:

The projects to meet the above requirements have been completed. This report provides brief summaries and photos related to each of the project locations.

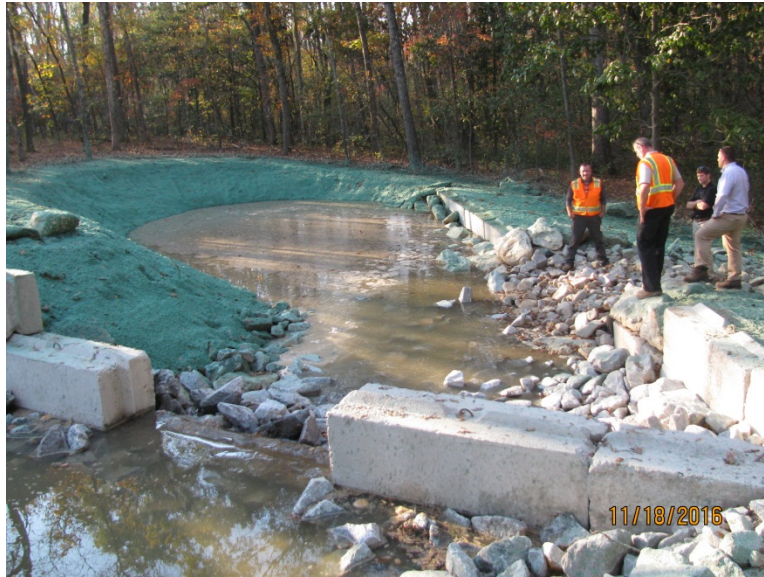
Broad rectangular weirs were constructed to regulate flow from pool to pool, and at the exit into the wetland. Under most low flow conditions, the first pool is expected to retain water at nearly full capacity, the second to retain water between half and full capacity, and the third to rarely retain water above half capacity. Treatment of low flows will be a combination of that expected from a wet retention pond and that expected in an infiltration basin. This control is well-suited to function fully as either a wet pond or an infiltration basin, though it is expected to serve as a combination of the two under most conditions.

*View of the third pool, facing downstream.*

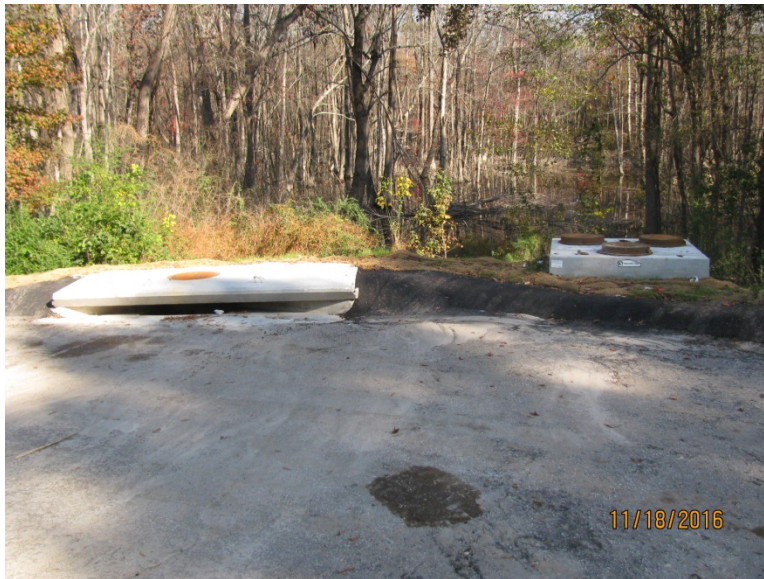
A Manufactured Treatment Device (MTD) was selected for this site. This site is restricted primarily by the square footage available for installation of a water quality control. Water collected in the inlet at the end of the cul-de-sac is routed to the MTD for treatment prior to discharge into the adjacent wetland. The subsurface MTD effectively treats low flows from the drainage area, while equipped to bypass larger flow volumes. Observations of the unit following rainfall events indicate the unit is functioning as designed.

*Surface view of Site 3 MTD and inlet*

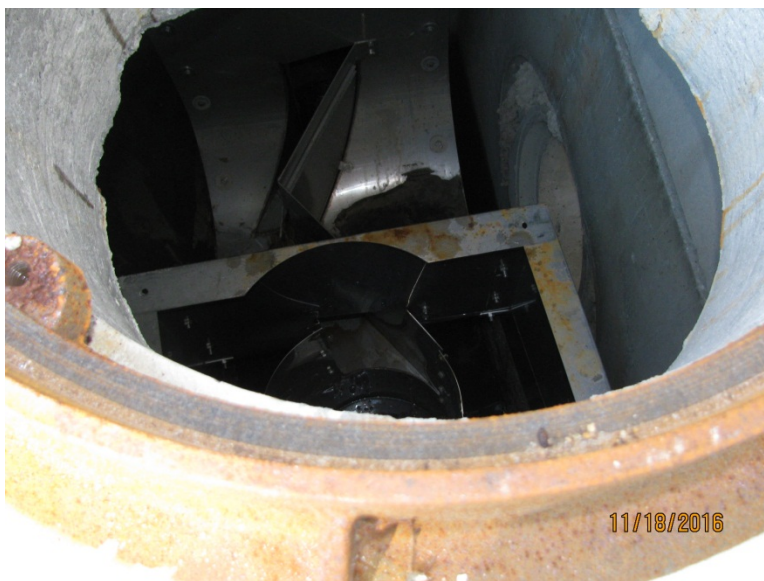
*Interior view of Site 3 MTD*

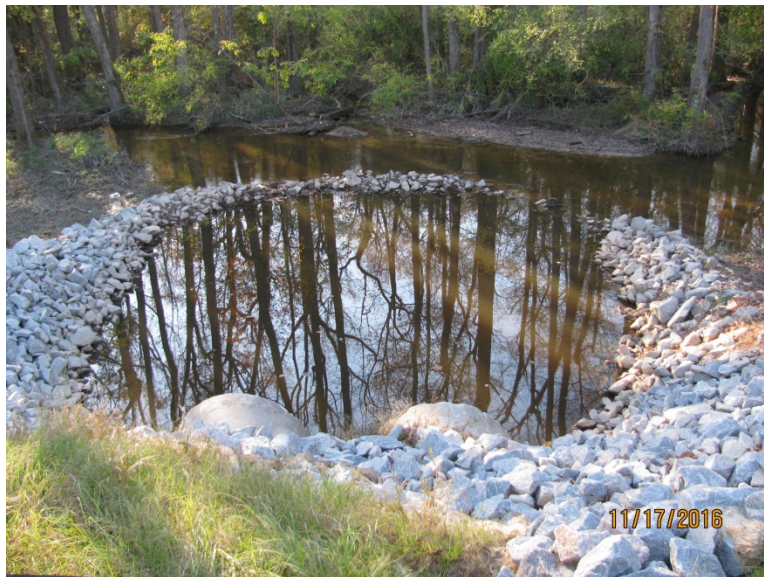
Large riprap plunge pools were selected to serve as erosion control at the two locations, 4B and 4C (note: 4A was eliminated early in the planning process). The plunge pools are of sufficient size and depth to dissipate energy from high velocity flows through the outfalls. Observations following several rainfall events indicate the pools are functioning as designed.

*Riprap plunge pool at Site 4C*

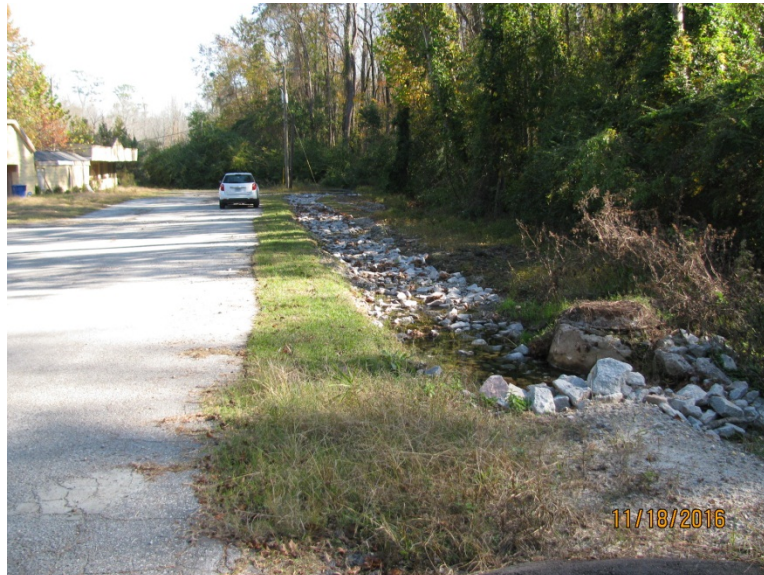
A subsurface vein of drainage stone was installed, then covered with additional stone and riprap. Low flows filter through the subsurface stone and empty into the riprap apron at the end of the swale. Larger flows will flow along the surface, over the riprap. Observations of the swale during low flows (which to date have remained constant), and after rainfall events, have indicated the swale is functioning as designed.

*Upstream side of the swale at Site 5*

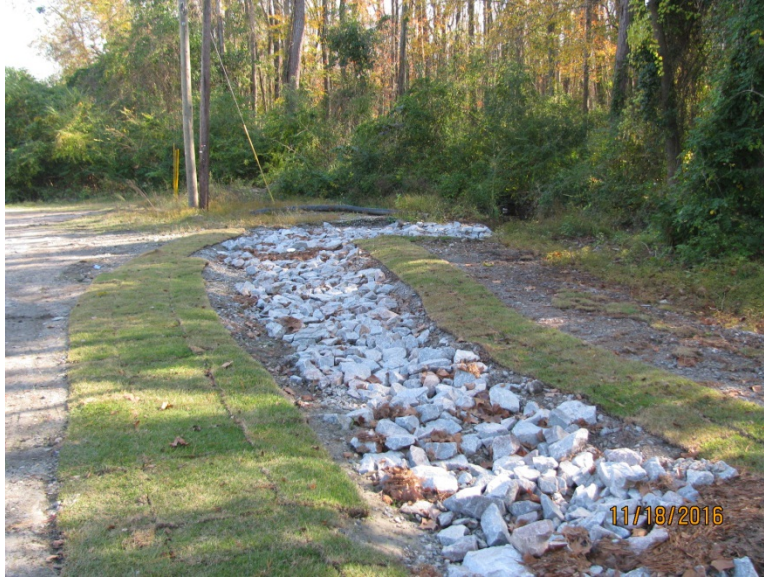
*Downstream side of the swale at Site 5*
